FIRECRACKERS

FROM

CHINA & INDIA

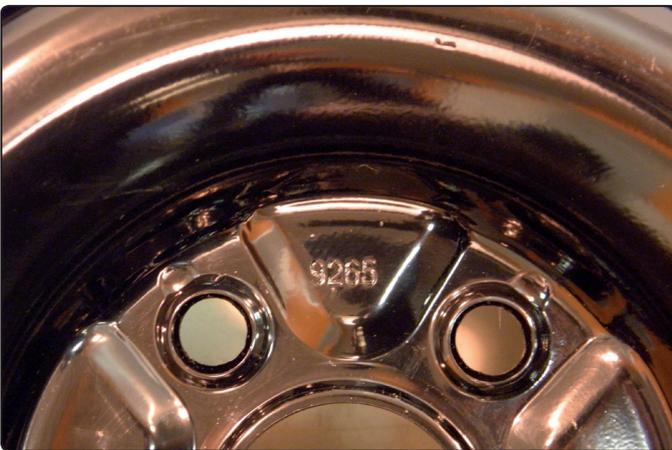
- **NOT EXISTING AT ALL**

EXAMPLE:

Toyota Avensis wheel 9265:

No homologation at all, insufficient identification but KFZ P/N faked.

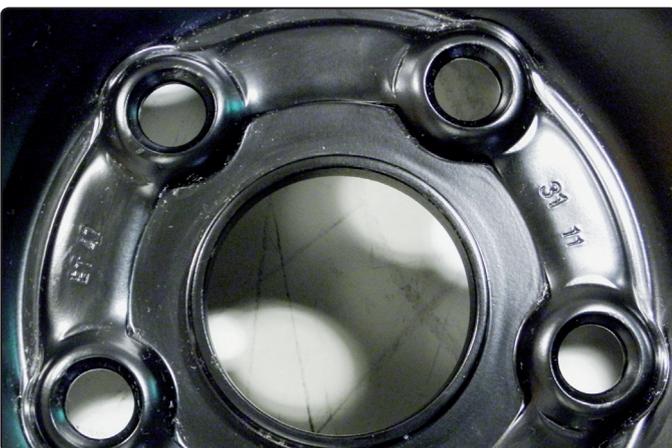
- **INCOMPLETE**

EXAMPLE:

Volkswagen Group wheel 9165: ABE not granted so far.

External wheel disc marking:

31-11 15x6J KBA48677 ET47

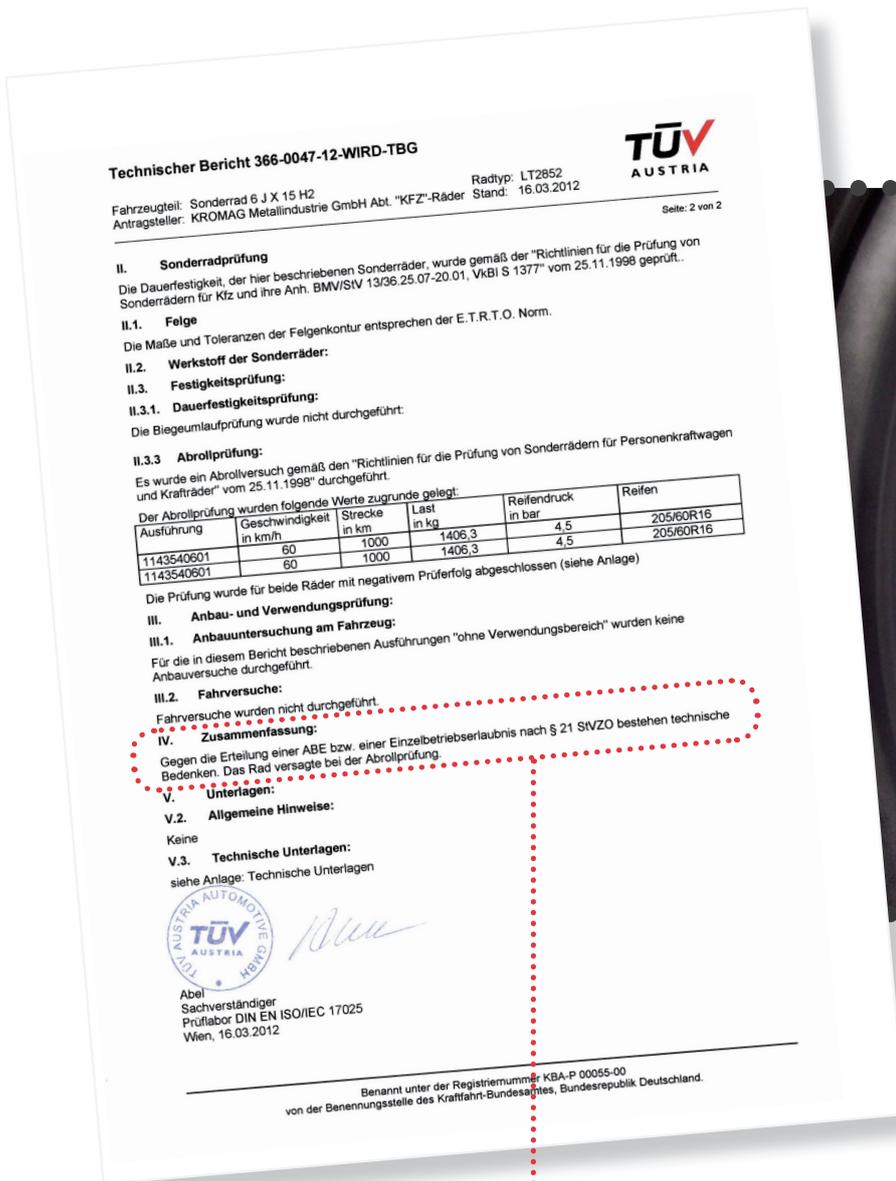
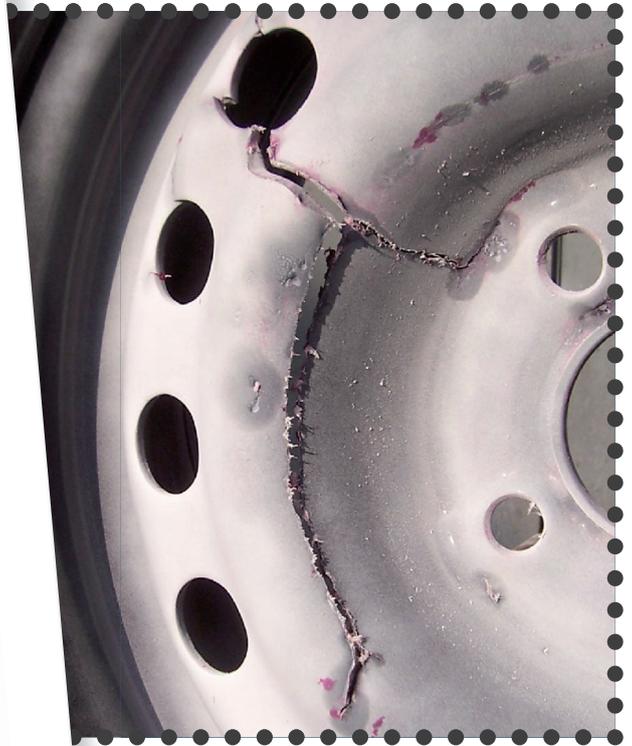
TÜV AUSTRIA REPORT

EXCERPT TÜV AUSTRIA REPORT:

IV. SUMMARY:

„There are technical concerns in granting an ABE or an individual type approval according to §21 StVZO. The wheel did not pass the rim rolling test.“

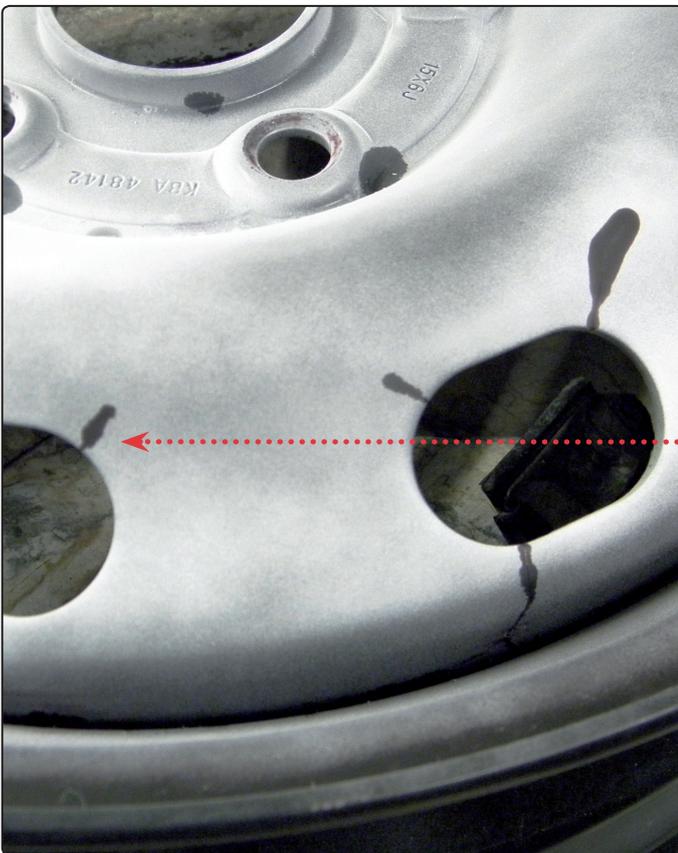
- **WHEEL LOAD INSUFFICIENT**

EXAMPLE:

Volkswagen Group wheel 9165:

- *Early crack on ventilation holes due to 555 i.s.o. 625 kg wheel load*

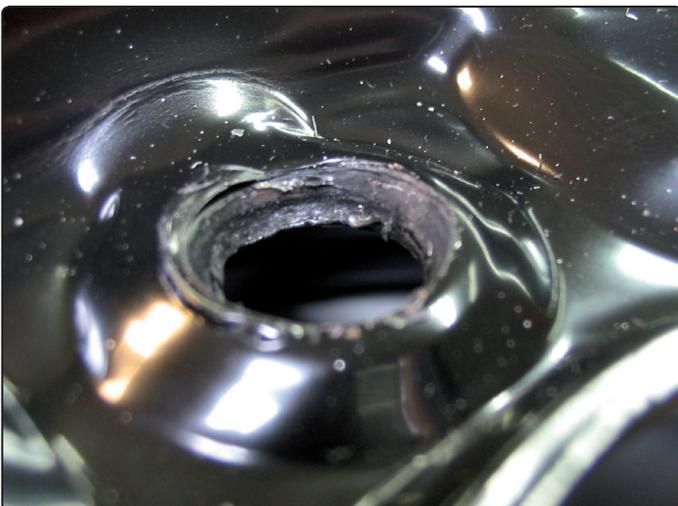
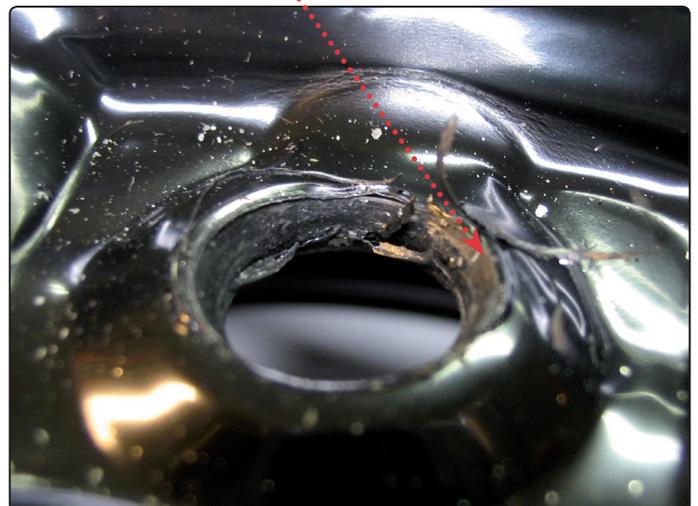
- **BOLT LOOSENING**

EXAMPLE:

Mazda wheel 9980:

Paintfilm too thick ○

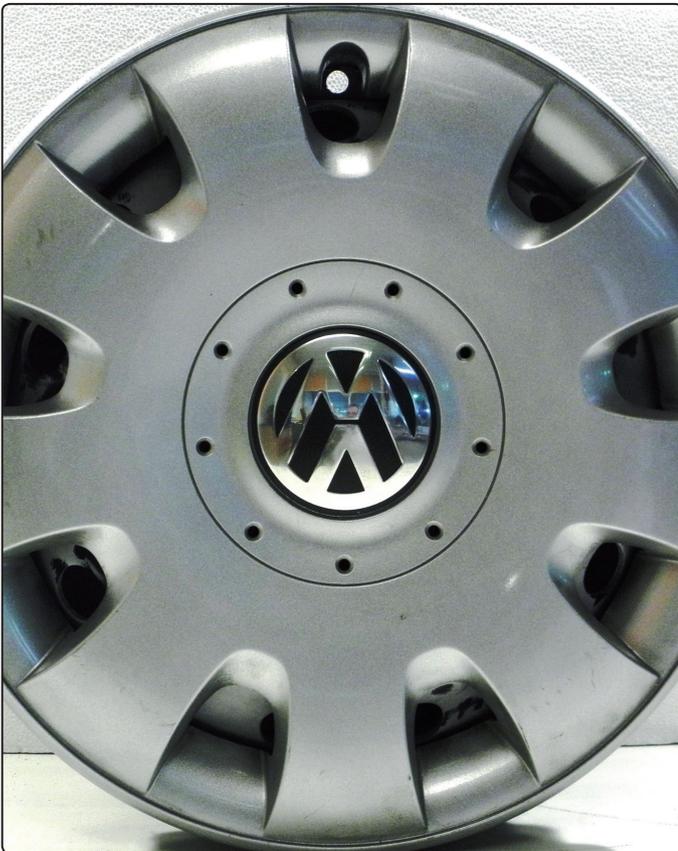
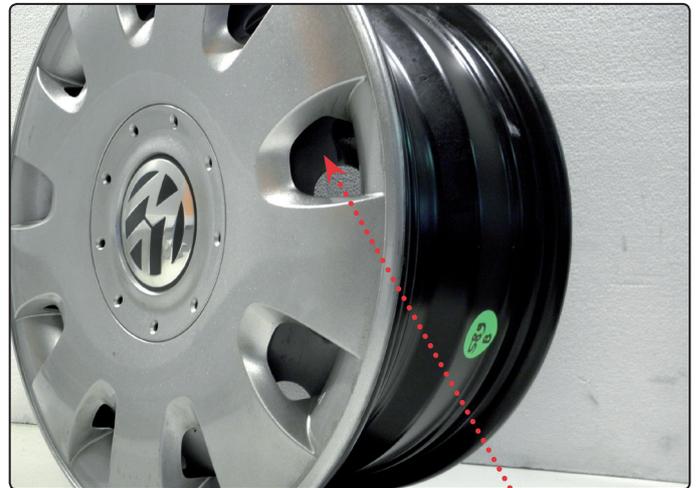
- **OVERHEATING OF BRAKES**

EXAMPLE:

Volkswagen Group wheel 9165:

10 instead of 20 vent holes + misalignment between vent holes (wheel) and wheel cover

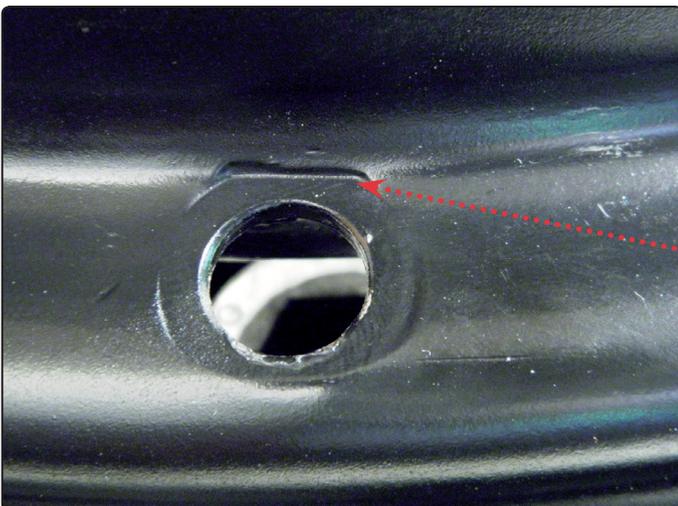
- **DAMAGE OF TIRE AND AIR VALVE**

EXAMPLE:

Volkswagen Group wheel 9165:

Burrs around the valve hole

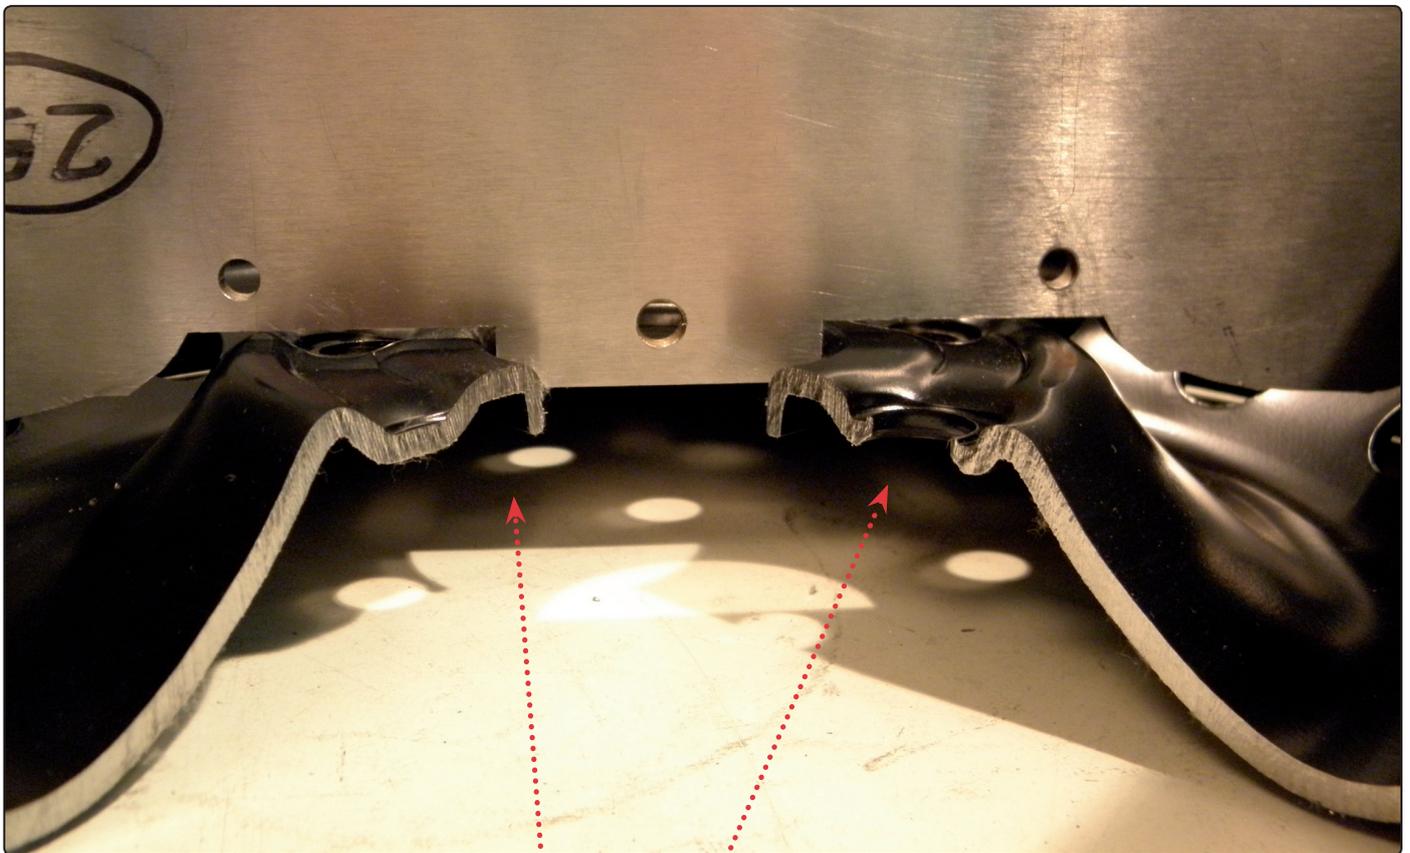
03 PLUG & PLAY BREAK CONTOUR

• BRAKE CONTOUR

EXAMPLE:

Volkswagen Group wheel 9165:
Wheel is not mountable on some Volkswagen group car models

• RUNOUT VALUES

Volkswagen Group wheel 9165:
All 3 samples far out of specs.

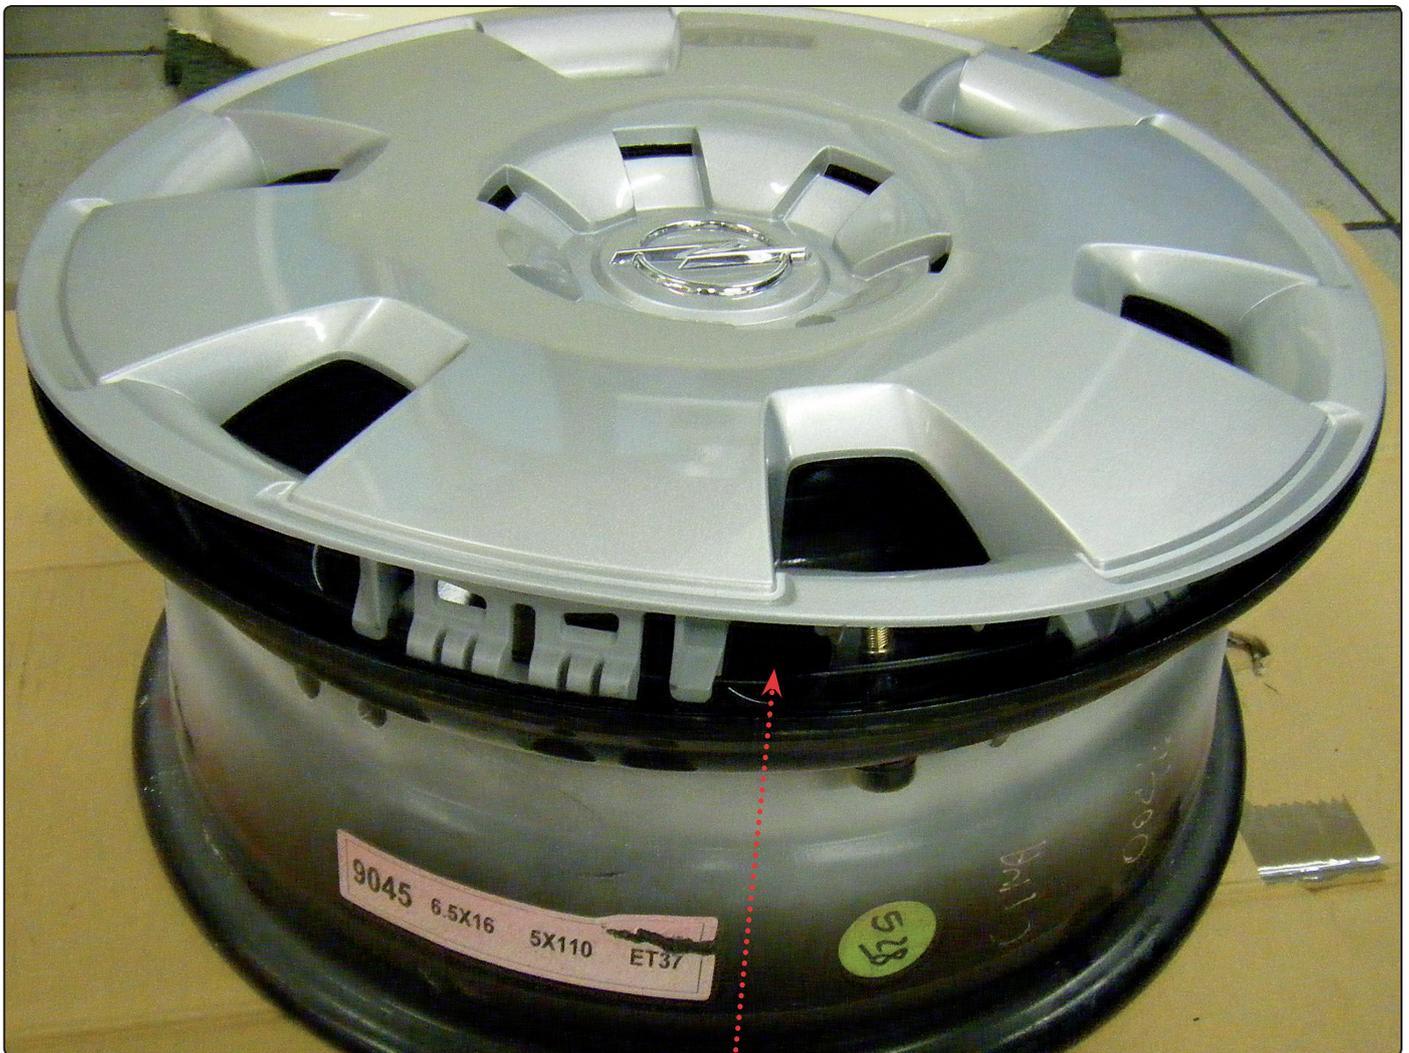
03 PLUG & PLAY WHEEL COVER

- **WHEEL COVER**

EXAMPLE:

Opel wheel 9045:

Wheel cover is not mountable due to different rim profile and material thickness not according to specifications

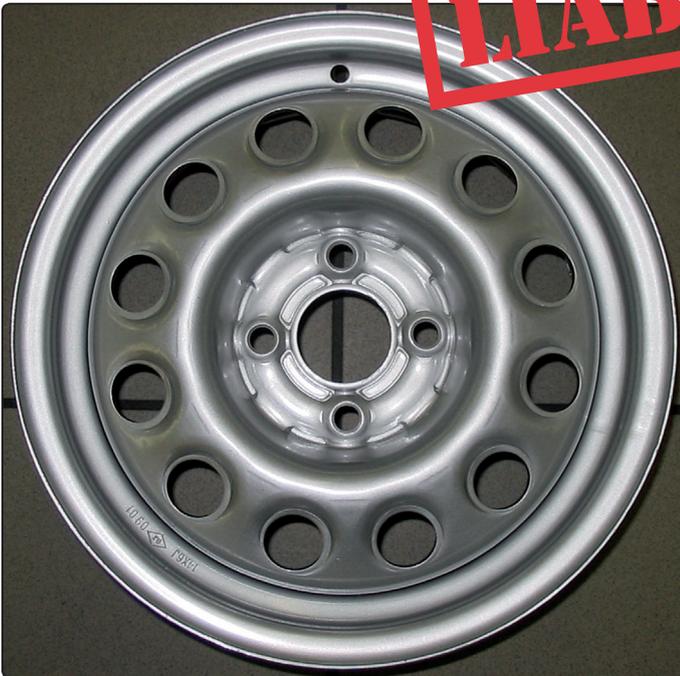
- **INCOMPLETE**

EXAMPLE:

*Volkswagen wheel 7500: Marking on rim
but none on wheel disc.*

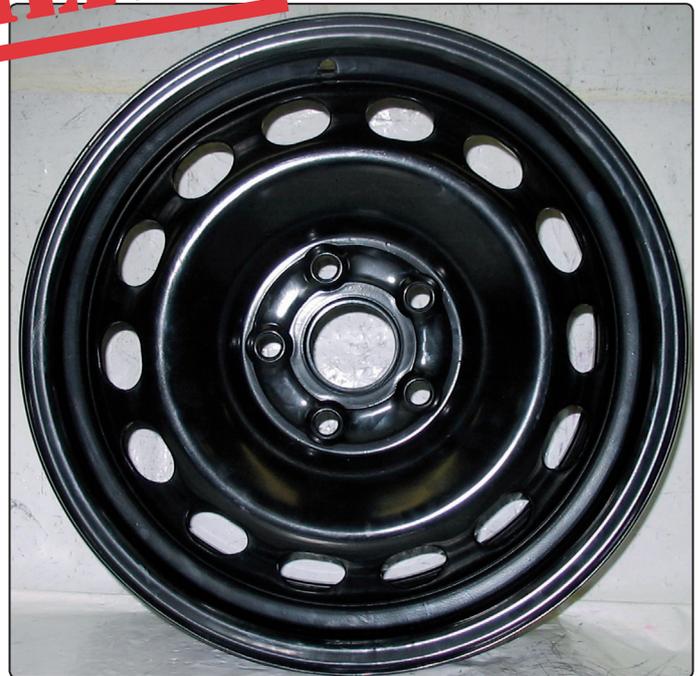
- **NONE**

EXAMPLE:

*Example Volkswagen wheel 9915:
No marking on rim and disc.*
